Case History on "Repair of Kiln Shell" At Ankit Metals & Power Limited, Jorehira.

The case study is about the repair of Kiln Shell crack of Kiln-2 of 350 TPD capacities. This was earlier repaired with E7018 alloy. During regular use a crack originated from the same repaired portion. The crack actually generated from manhole adapter area in both the sides in semi circular fashion

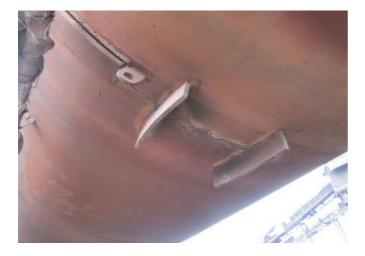
Crack -1:

Length of the Crack : 2000 mm.Depth of the Crack : 25 mm.

Crack-2:

Length of the Crack : 800 mm.Depth of the Crack : 25 mm

Crack-3: (Adapter joining)

• Circumference of adapter: 2000 mm.

• Depth of the Crack : 25 mm

Analysing the cause of crack & its nature & depending on the working parameters, EWAC Alloys Limited suggested welding alloy CPHFD 011 for repairing of the complete crack.
